# Hirshhorn Sculpture Garden Revitalization

## Draft Assessment of Effects on Historic Resources

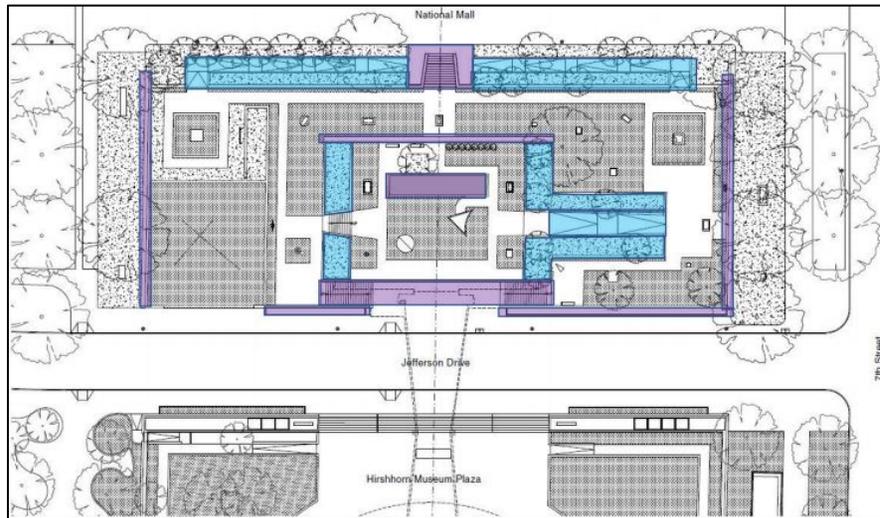
1974, 1981 Period of Significance Character Defining Features:
Setting for Rotating Display of Sculpture*
Recessed Grade Below the National Mall*
Concrete Walls (Perimeter and Inner Partition)*
Reflecting Pool*
South Stairs*
North Stair*
Hardscape Paving
Garden “Rooms”
Lateral North Ramps
Intermediate East Ramp
* Based on Hirshhorn Museum and Sculpture Garden Determination of Eligibility

1974 Features
  1981 Features
 \*Recessed Grade, Setting for Display of Sculpture, and Hardscape Paving are not annotated for clarity.

The table below identifies character defining features of the Hirshhorn Museum Sculpture Garden. These features individually and collectively contribute to the character of the Sculpture Garden. Character defining features were present in the Sculpture Garden during the period of significance (1974, 1981) and have retained integrity to that period.
