**Hirshhorn Sculpture Garden Revitalization
Assessment of Effects on Historic Resources**

August 2020

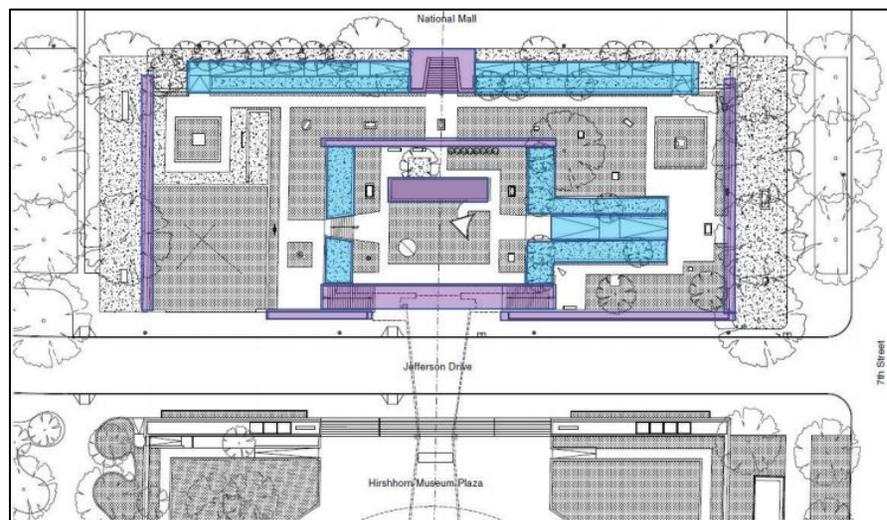
The table below identifies character defining features of the Hirshhorn Museum Sculpture Garden. These features individually and collectively contribute to the character of the Sculpture Garden. Character defining features were present in the Sculpture Garden during the period of significance (1974, 1981) and have retained integrity to that period.

1974 Features
 1981 Features
 *Recessed Grade, Setting for Display of Sculpture, and Hardscape Paving are not annotated for clarity.

1974, 1981 Period of Significance Character Defining Features:
Setting for Rotating Display of Sculpture*
Recessed Grade Below the National Mall*
Concrete Walls (Perimeter and Inner Partition)*
Reflecting Pool*
South Stairs*
North Stair*
Hardscape Paving
Garden “Rooms”
Lateral North Ramps
Intermediate East Ramp
* Based on Hirshhorn Museum and Sculpture Garden Determination of Eligibility
